# BUREAU OF SHIPS GROUP TECHNICAL INSPECTION REPORT

⑥ OPERATION CROSSROADS.  
U.S.S. DAWSON (APA79)

TEST ABLE (U).

OPERATION CROSSROADS

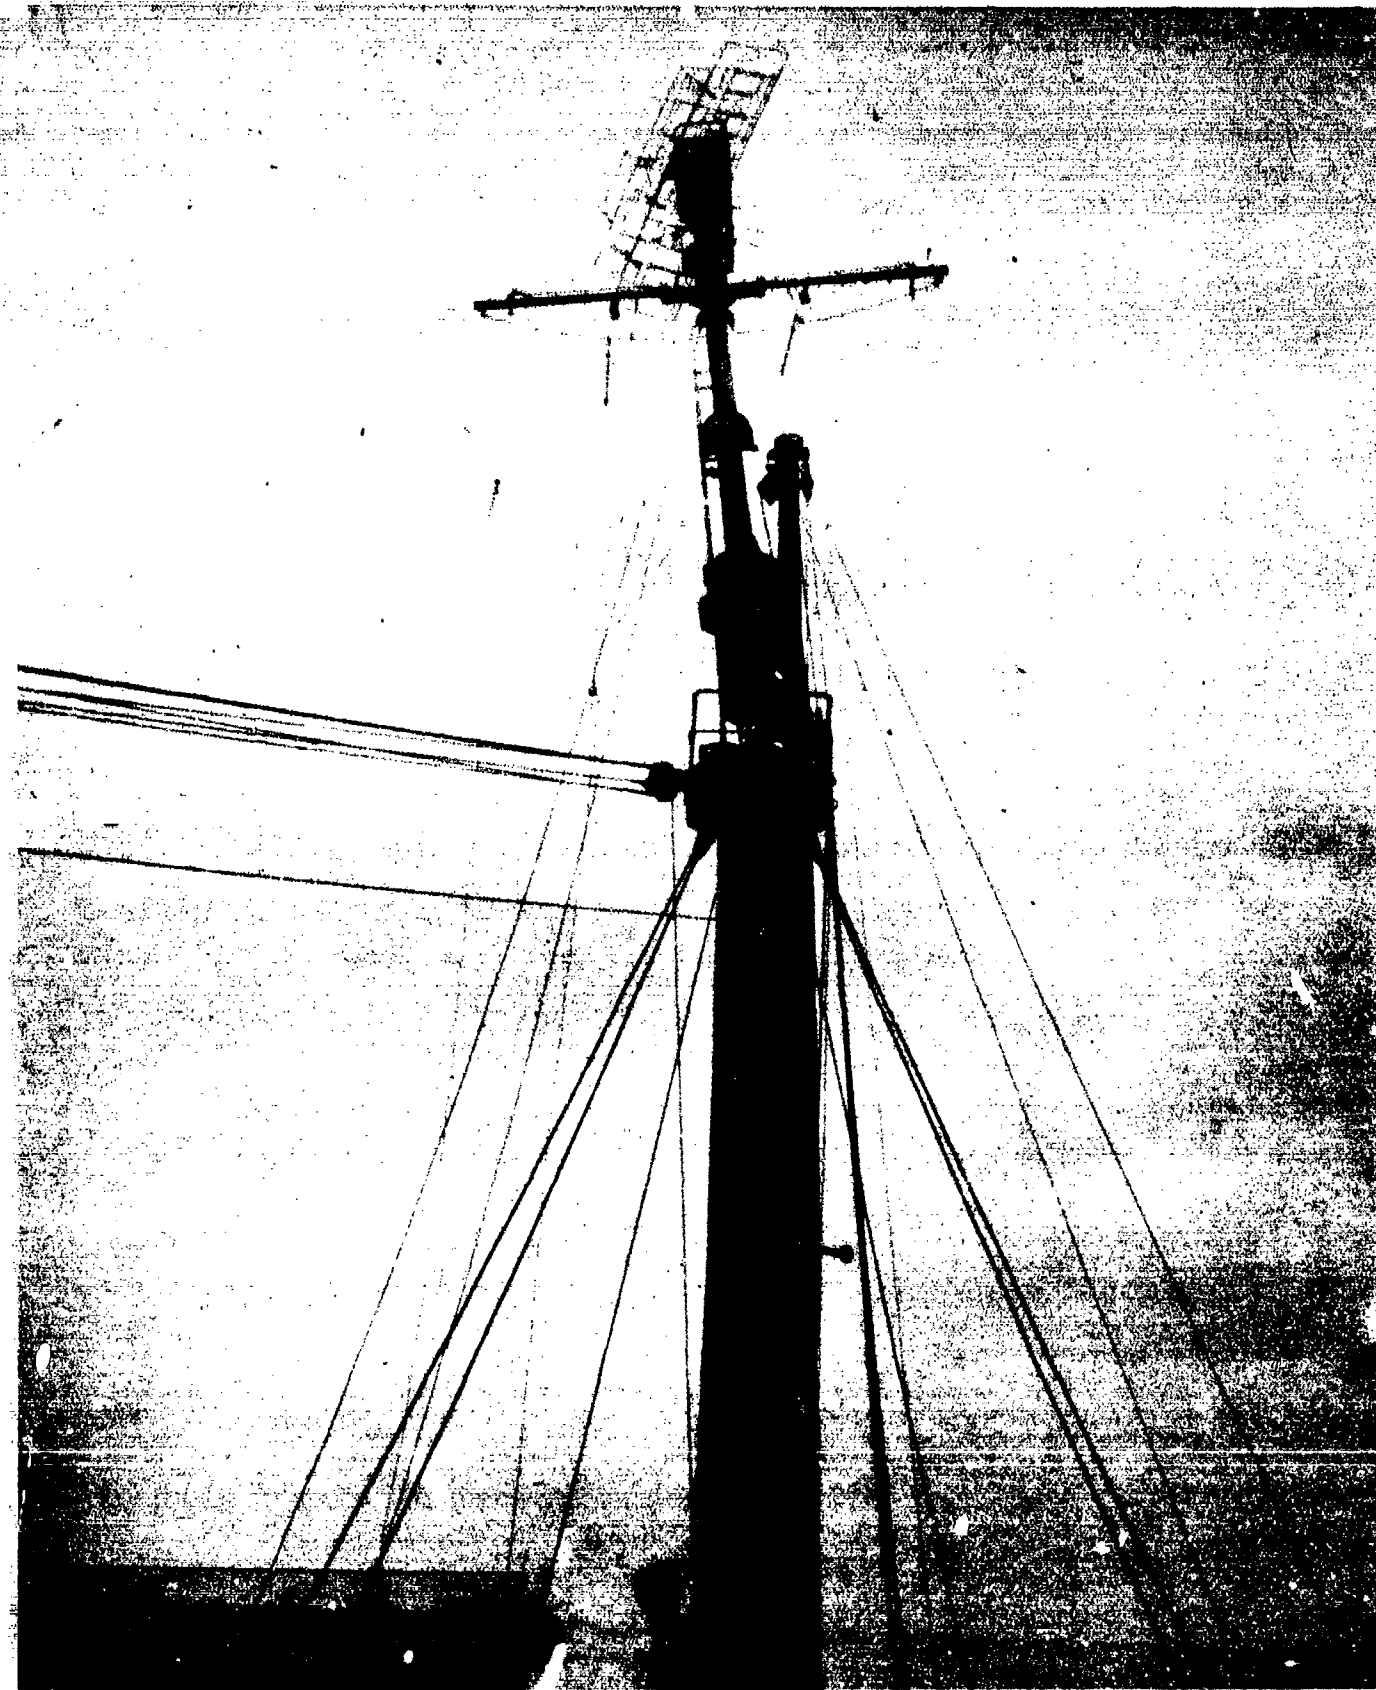
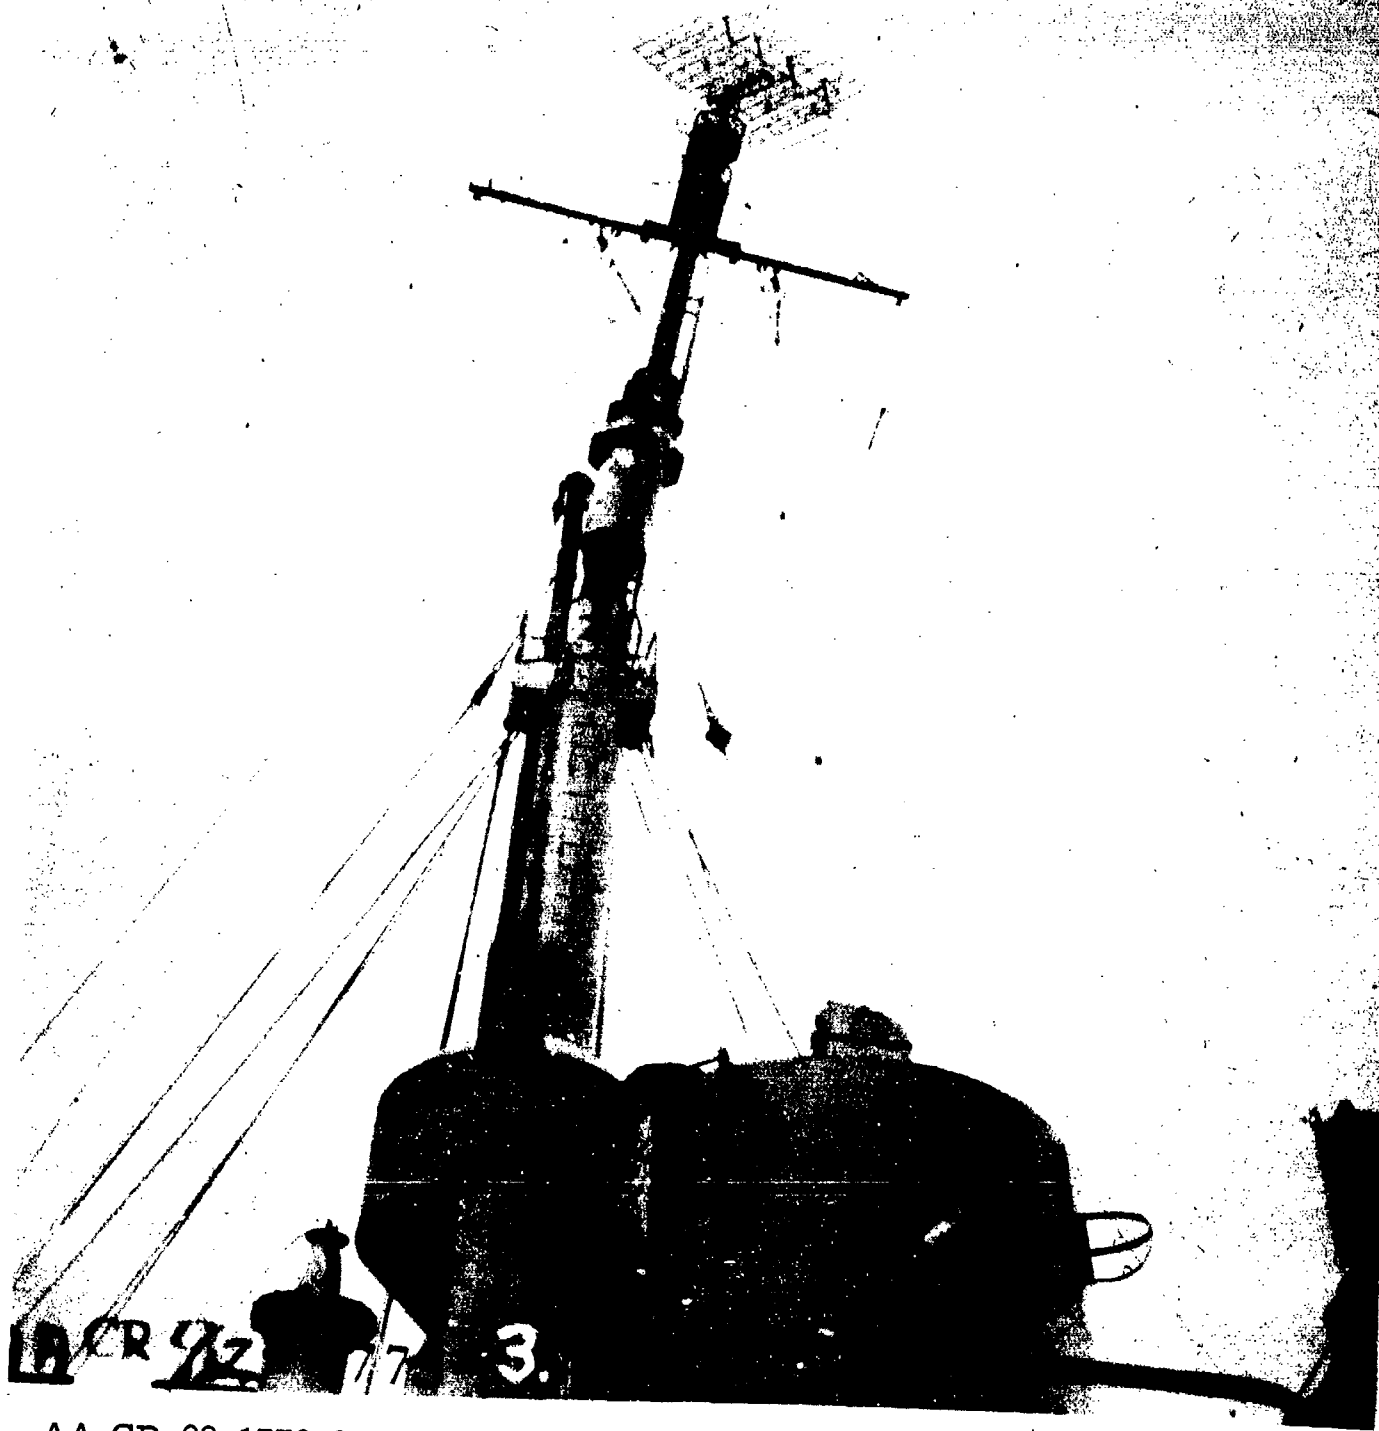
AA-CR-88-2103-1. Looking up and aft, showing bent main topmast and damaged radar screen.

AA-CR-92-1773-3. Looking up and forward, showing bent main topmast and damaged radar screen.

Topmasts should be eliminated and radar screens should be made retractible or readily replaceable by spares.

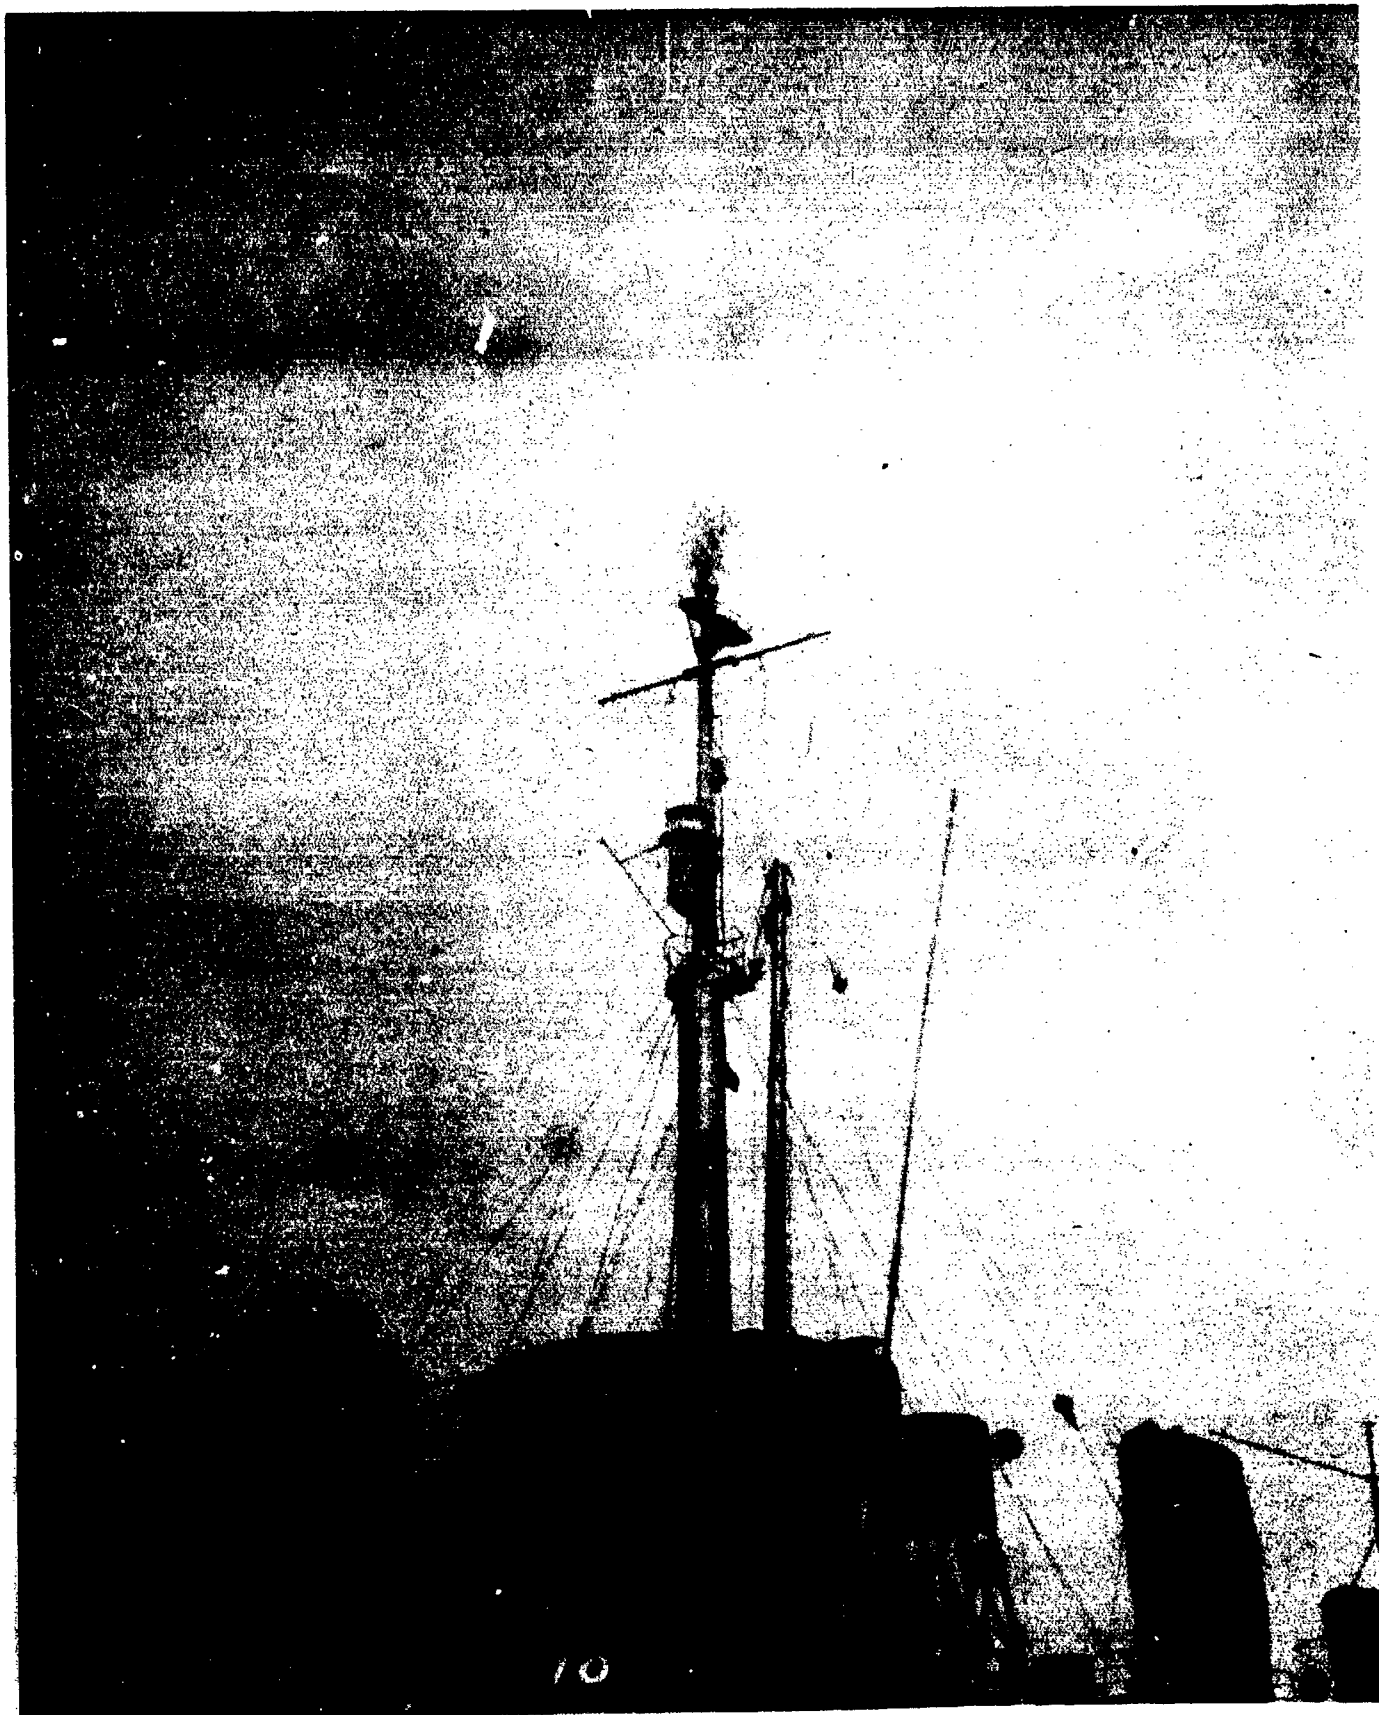
AA-CR-82-1922-10. Looking forward and to port showing damaged radar screen on main mast.

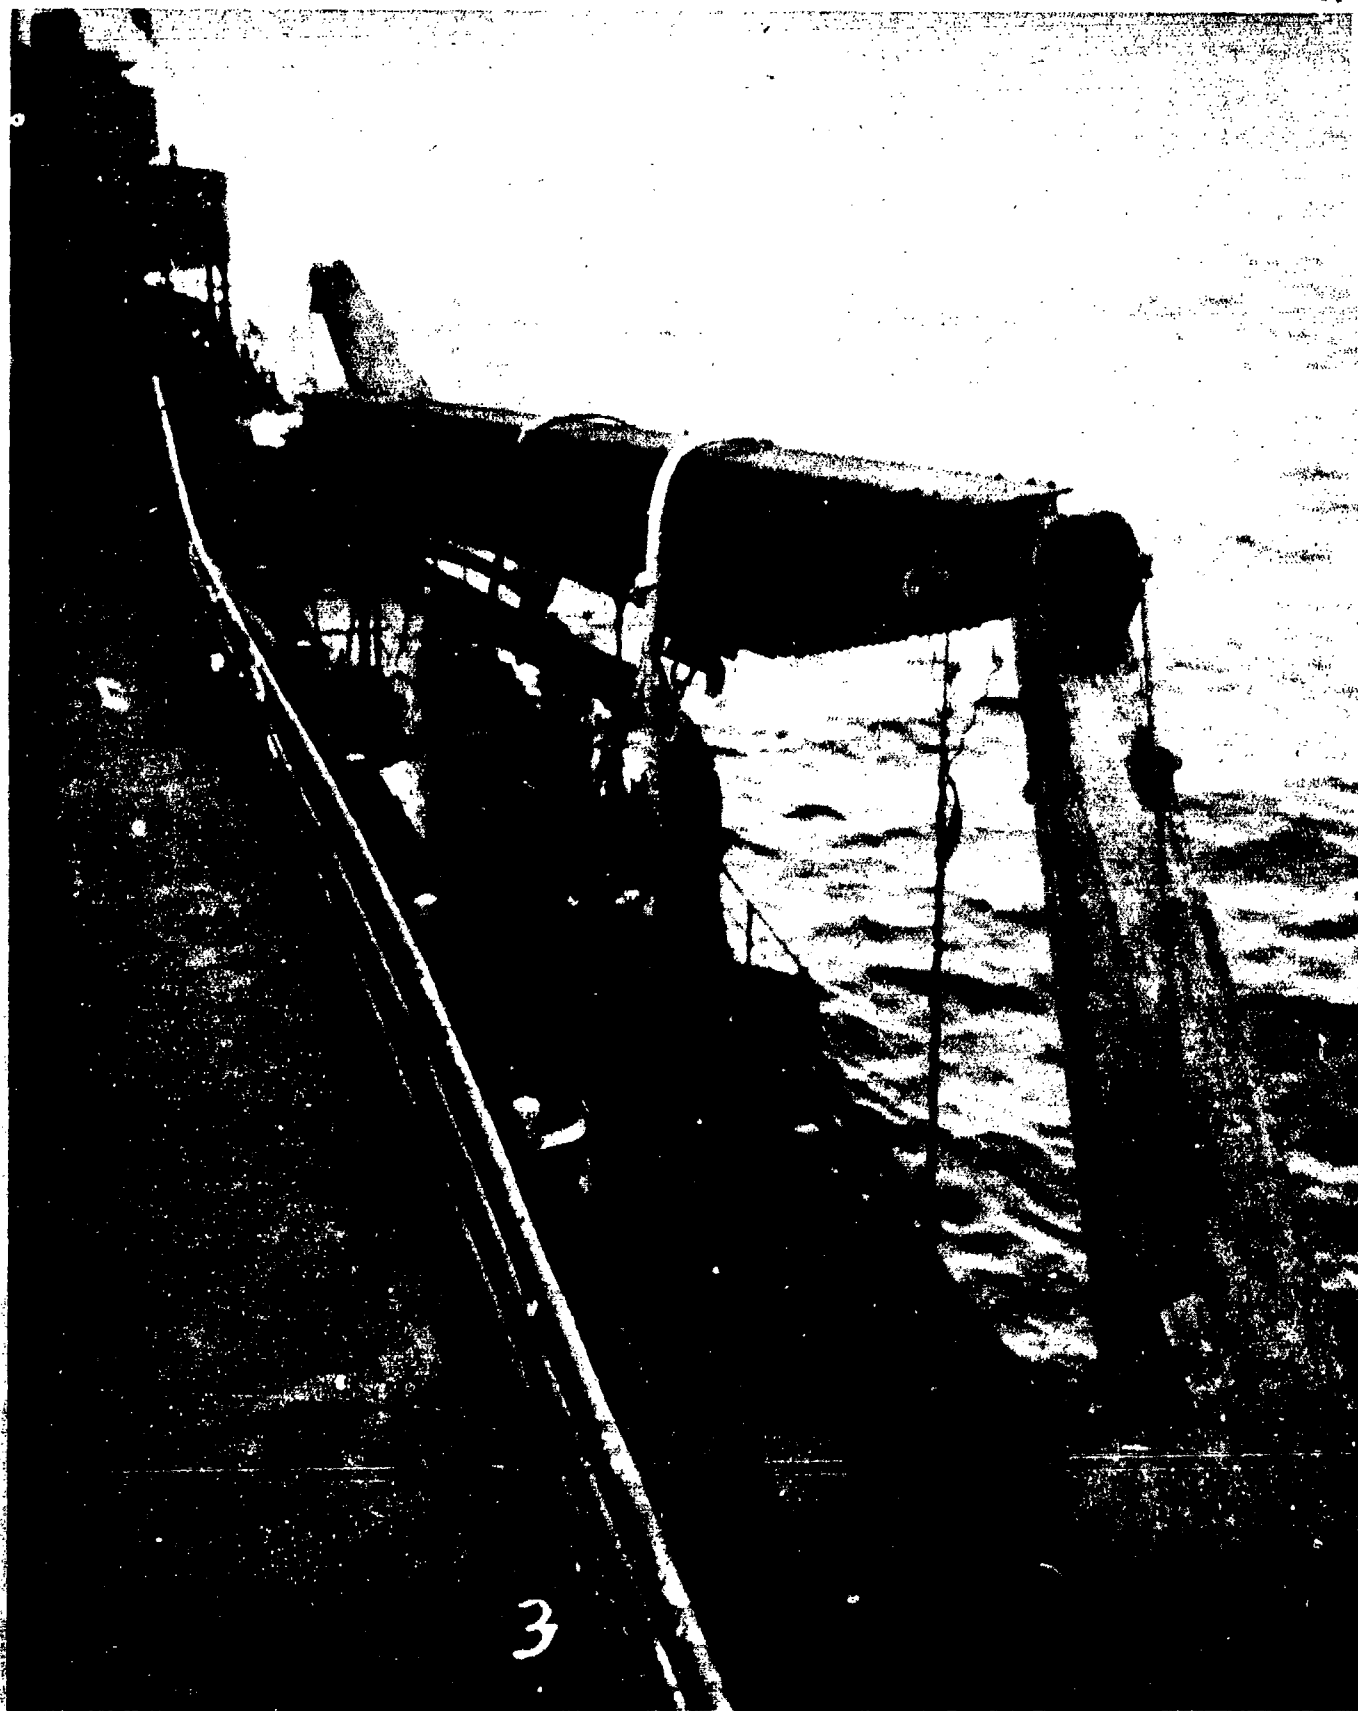
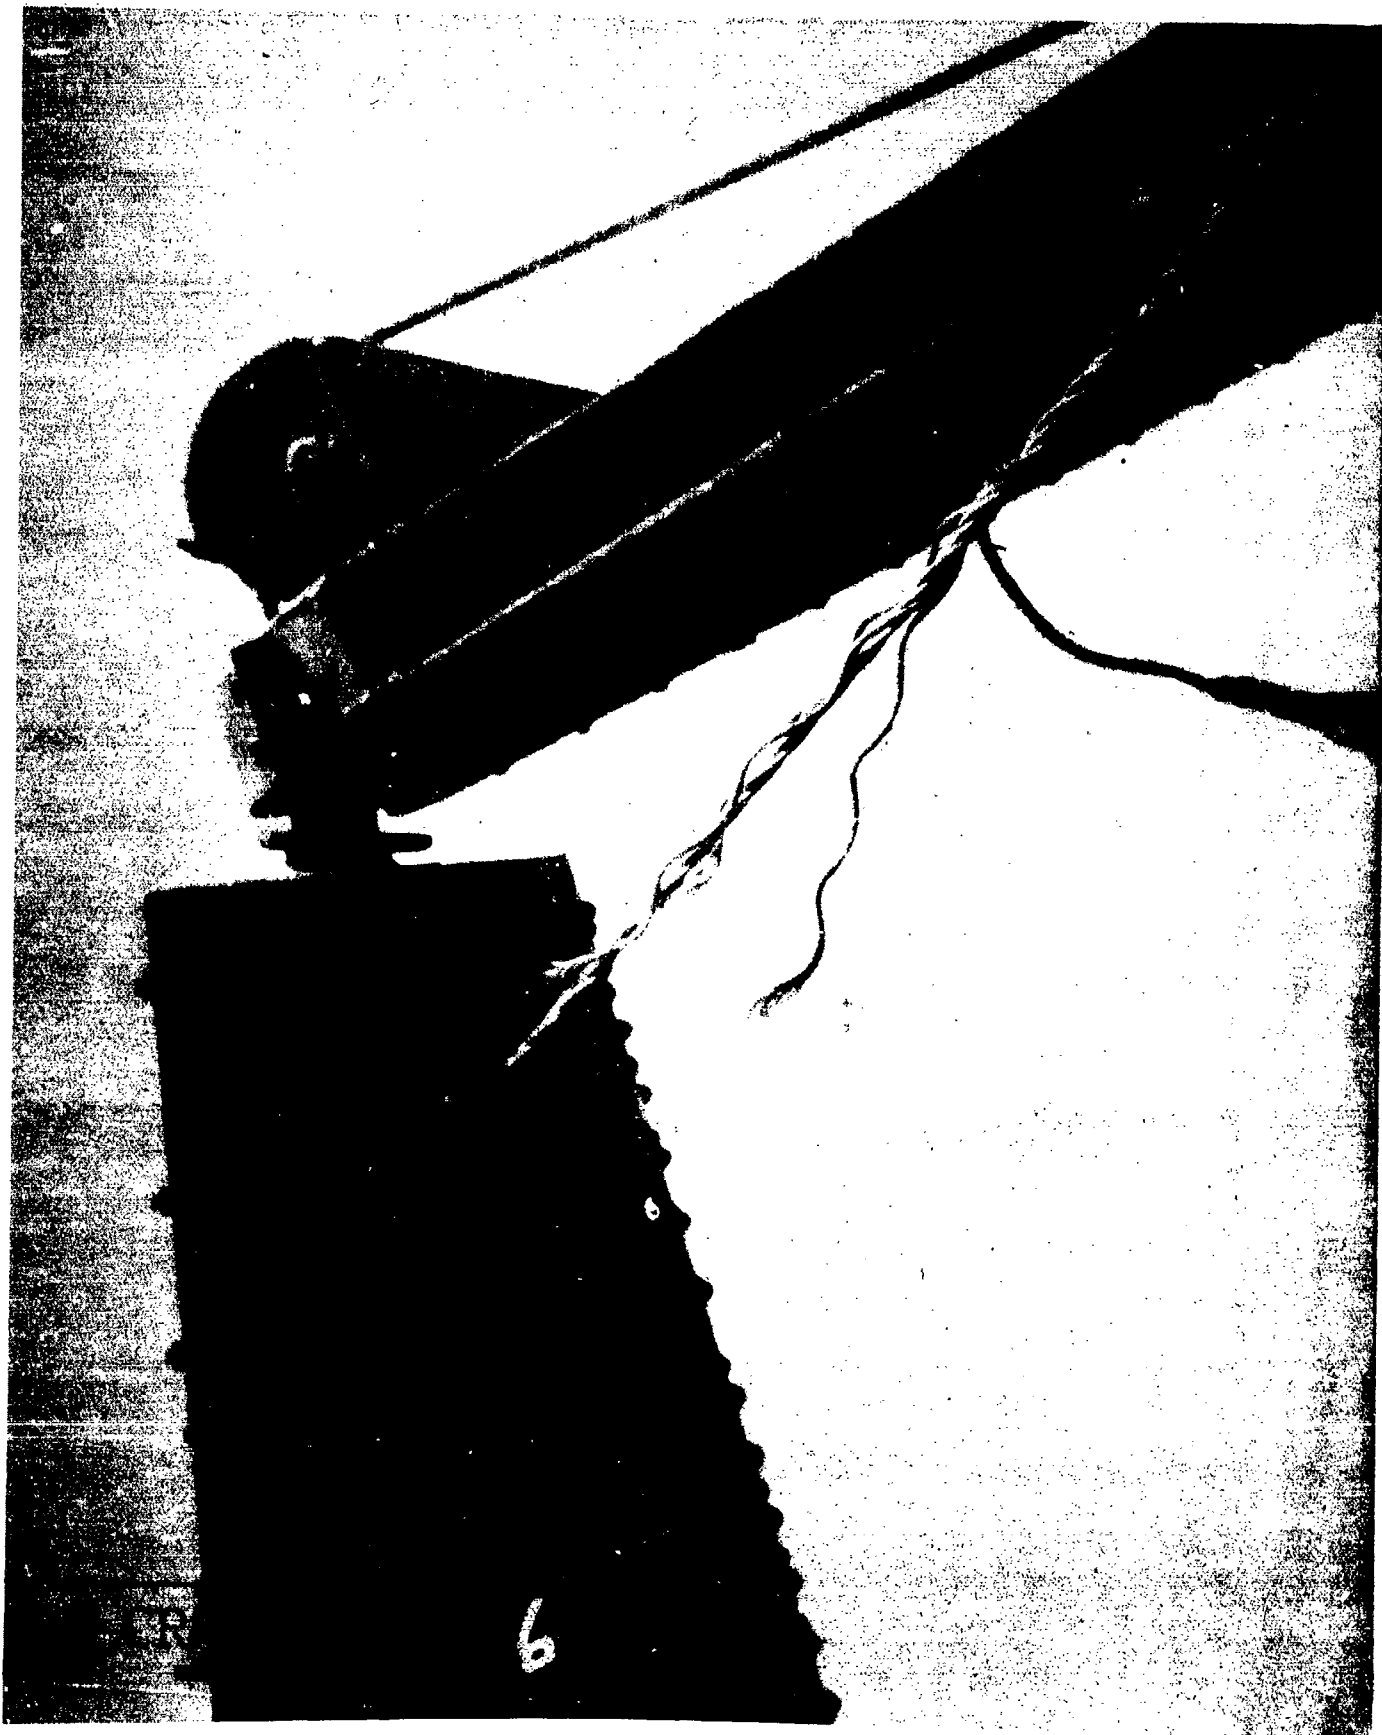
AA-CR-62-2169-3. Looking aft at No. 4 davit.

The outer casings of both stacks were considerably pushed in by blast pressure and the galley smokestack was flattened between the casings of the after stack. Both Welin davits on the port side were severely damaged structurally. No. 4 davit (after port) is considered to be beyond repair.

Both port Welin davits are inoperable because of structural damage. Neither can be repaired by the ship's force.

The after one is probably beyond repair. One electric drinking fountain is probably beyond repair. Otherwise, there was no damage that affected operation of machinery.

It is recommended that a study be made to determine whether Welin davits can be made more resistant to blast pressure.

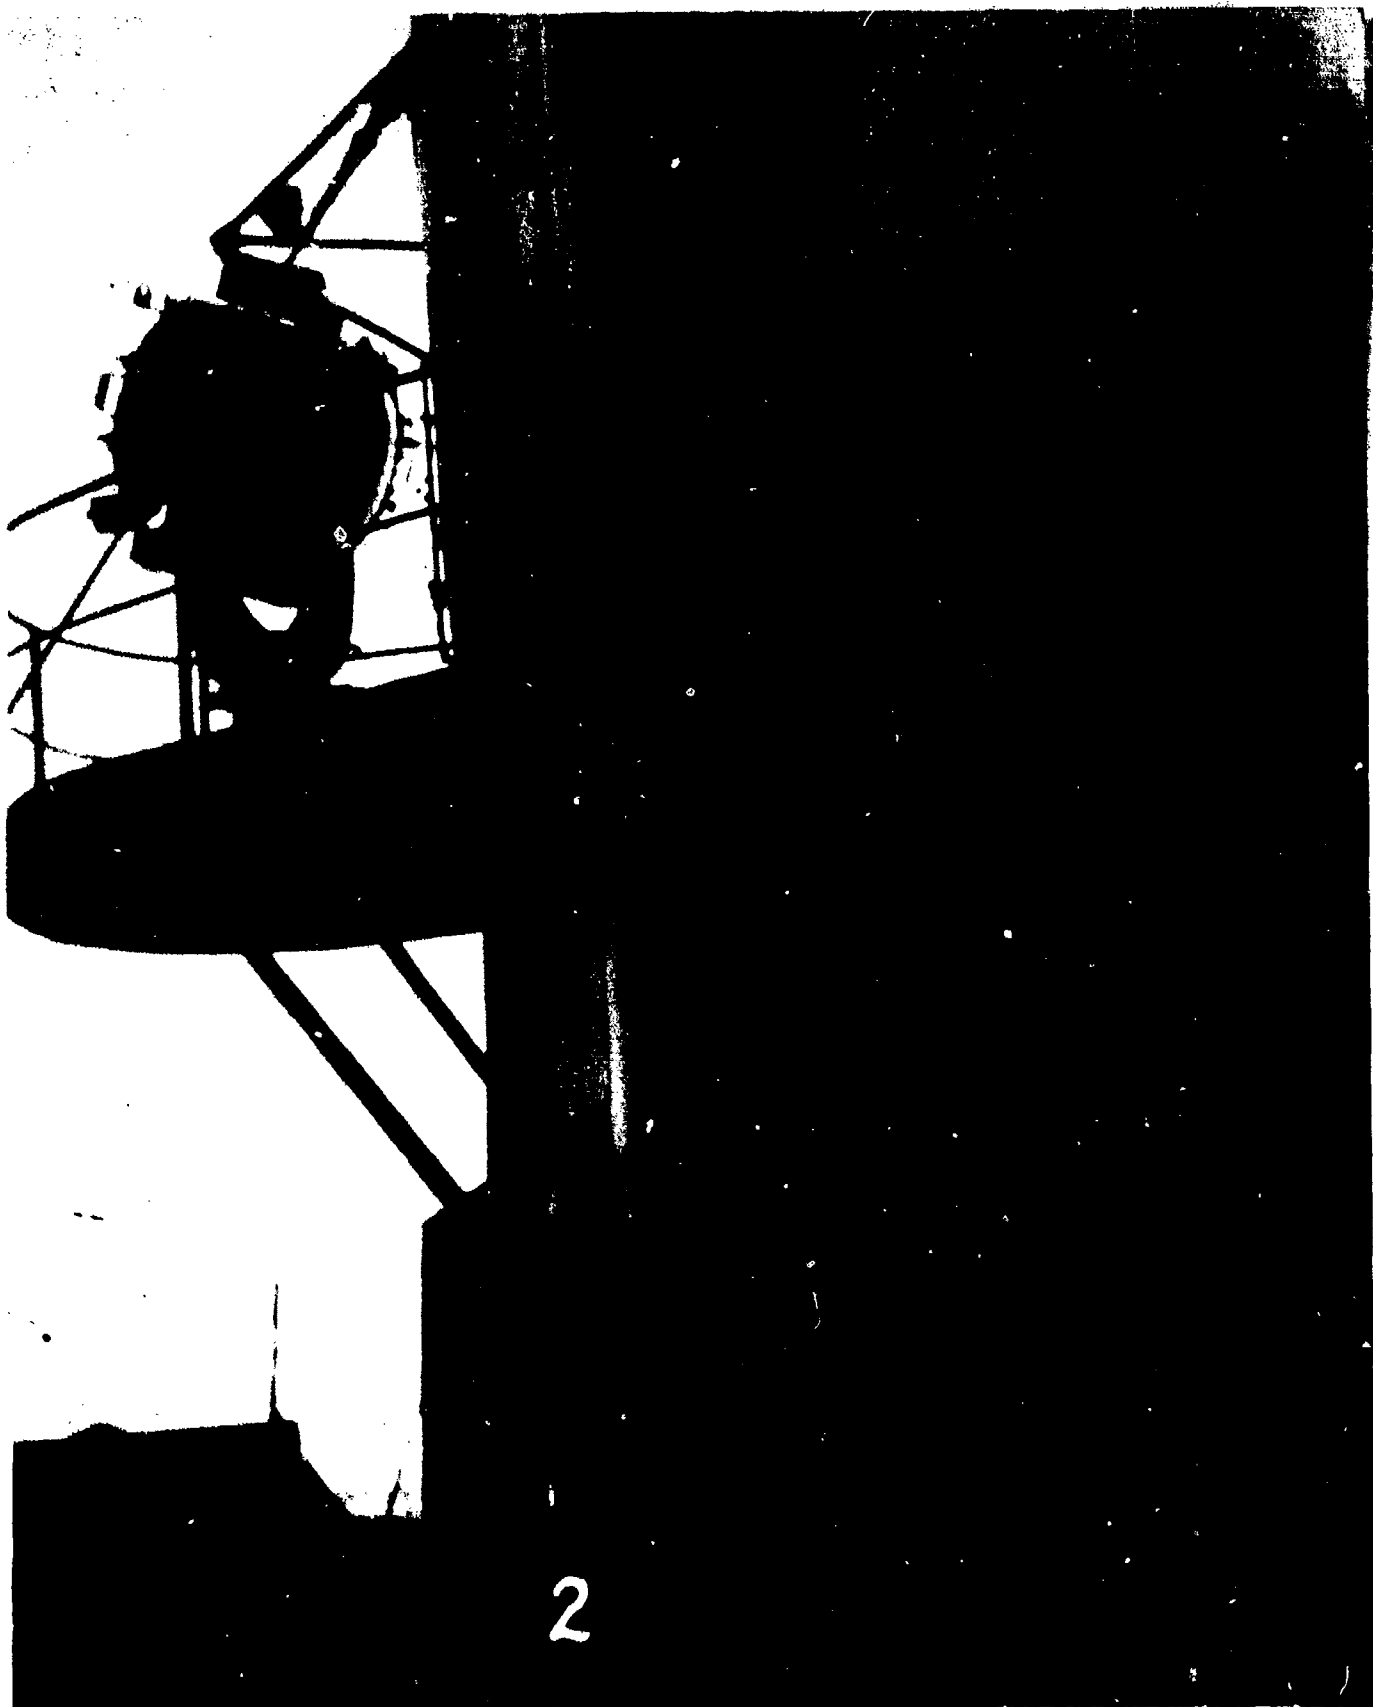
AA-CR-62-2169-2. Forward stack, showing dish on port quarter.

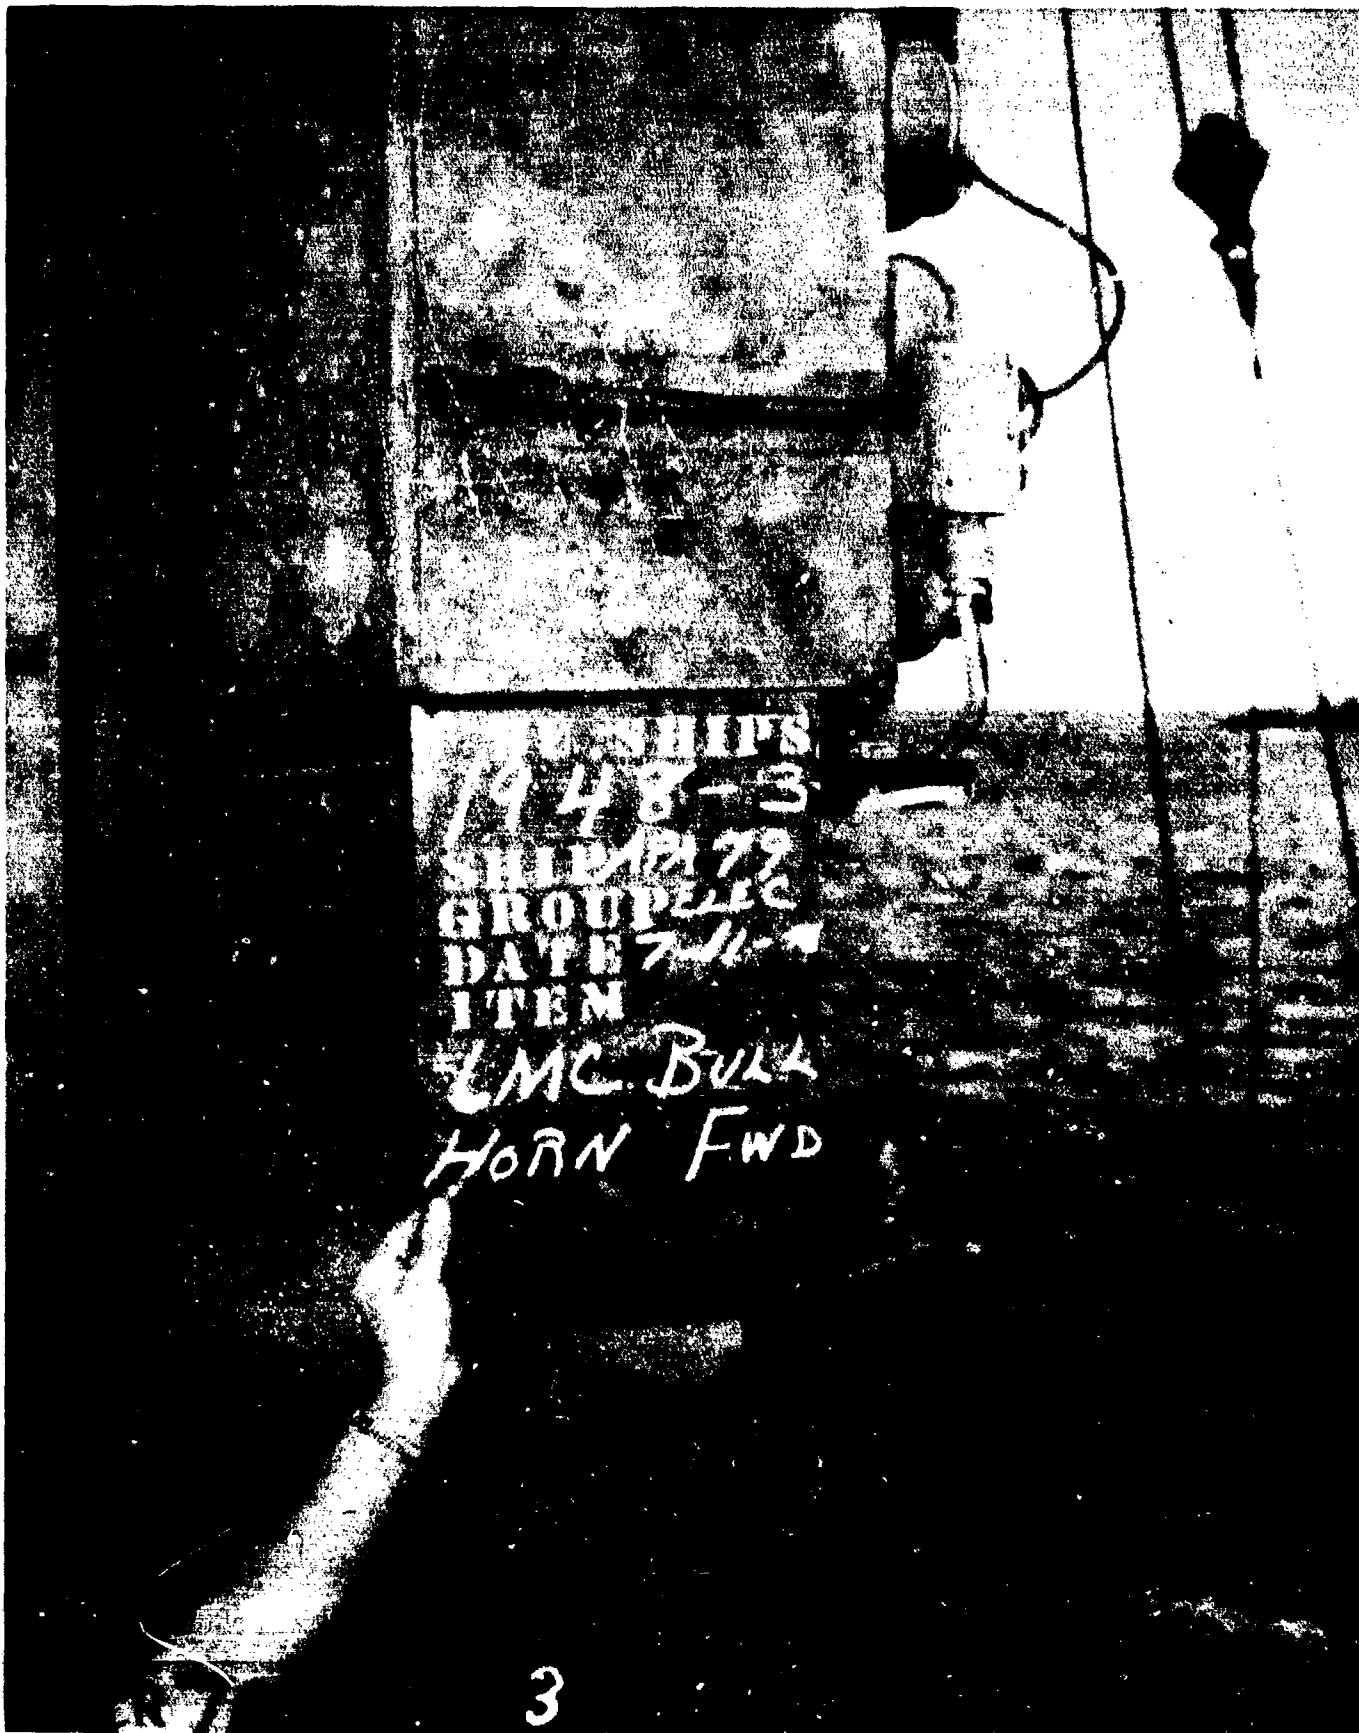
4. The tearing of one reproducer from its mounting.
  5. The bent forward 6 MC bull horn.
  6. The cracking of the dial window on the Rudder Angle Indicator at the Secondary Control Station.
  7. The anemometer cups carrying away.
- (e) Effects peculiar to the atomic bomb.

AA-CR-78-1948-3. Forward 6 MC bull horn, showing the effects of the air blast.

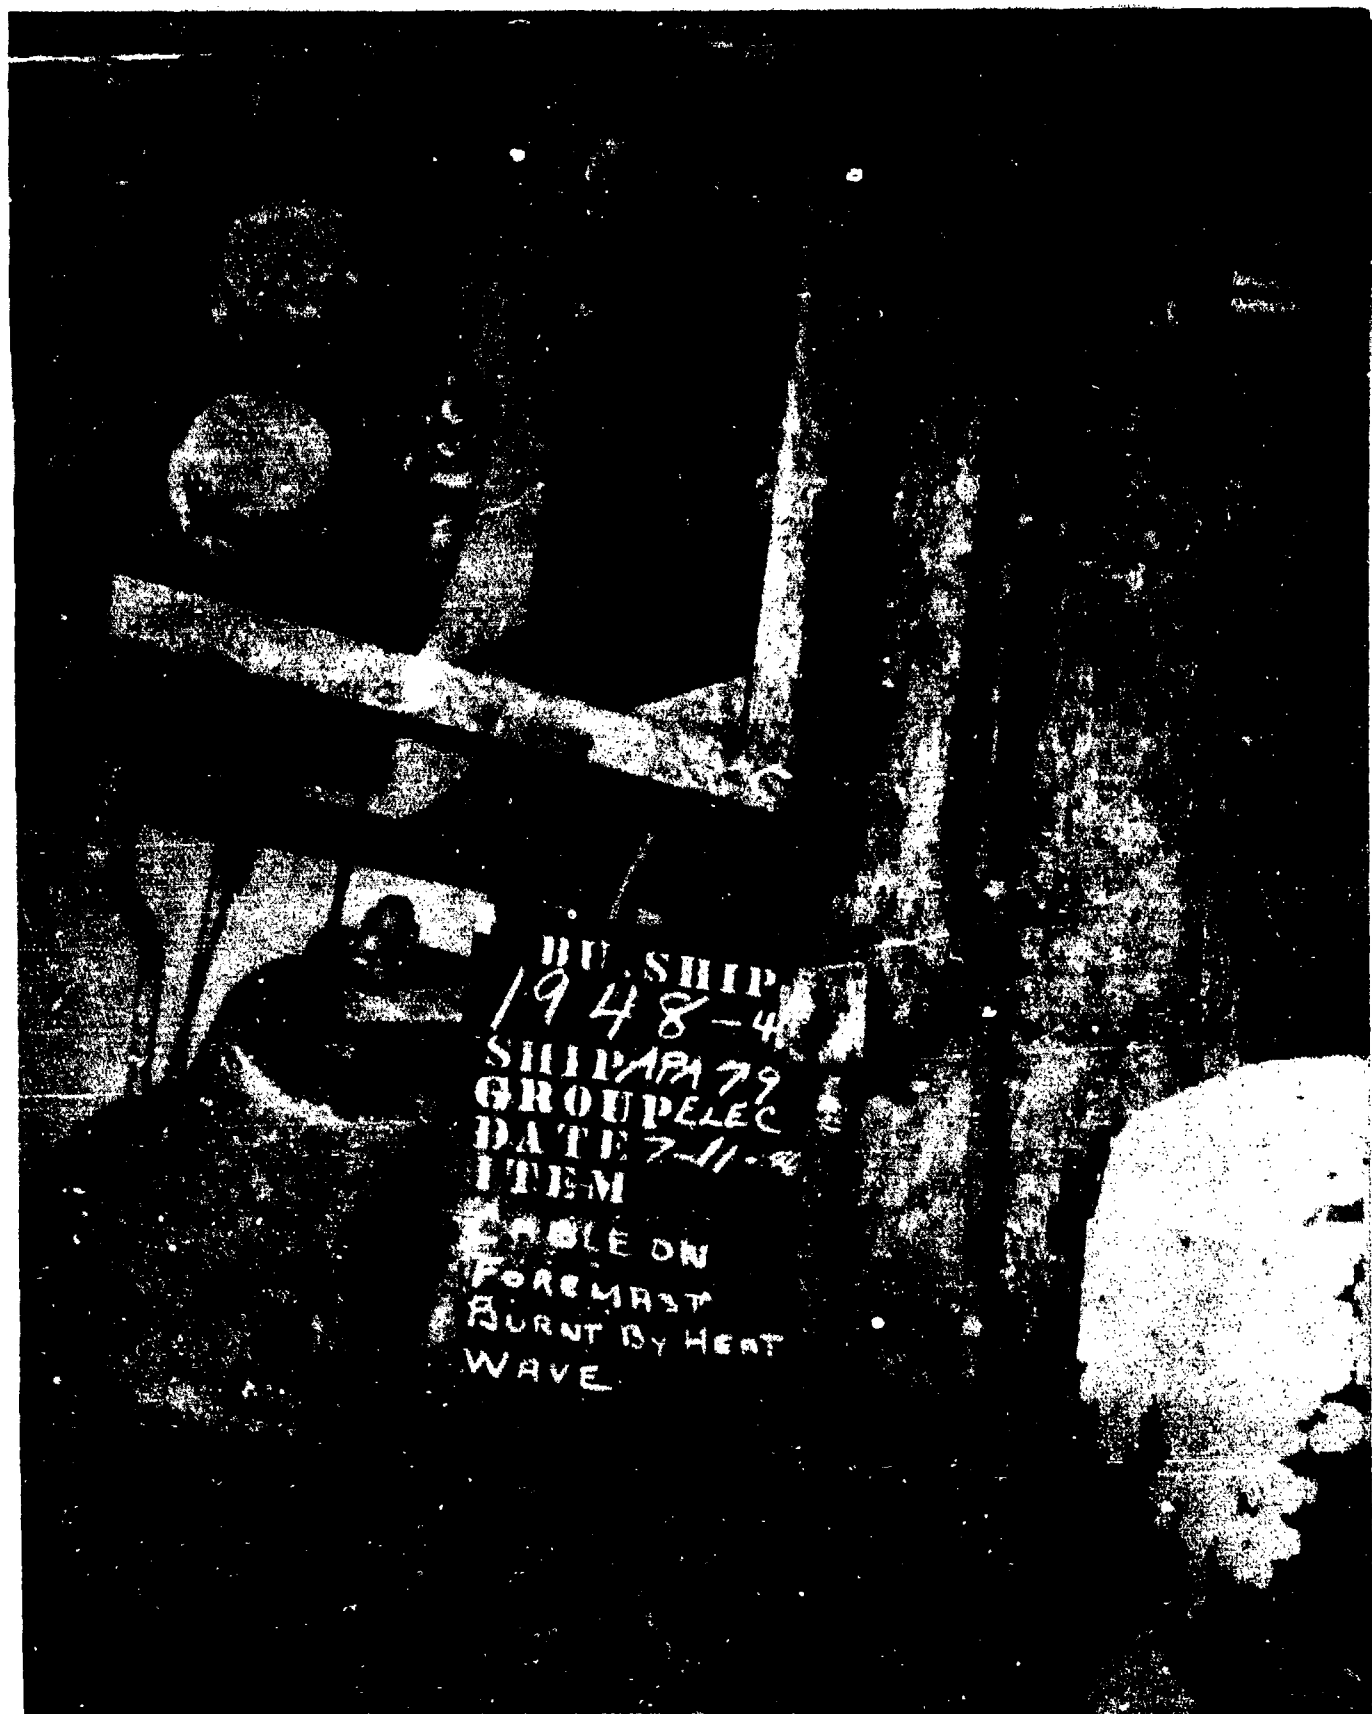
A small fire on the starboard side of the forward deck house at frame 27, destroyed the insulation on a sound powered telephone cable and a call bell cable. It is also believed that this fire contributed to the damage to cables on the lower part of the foremast.

AA-CR-78-1948-4. Showing the effects of radiant heat on the cables installed on the foremast. Note insulation seeping through armor.

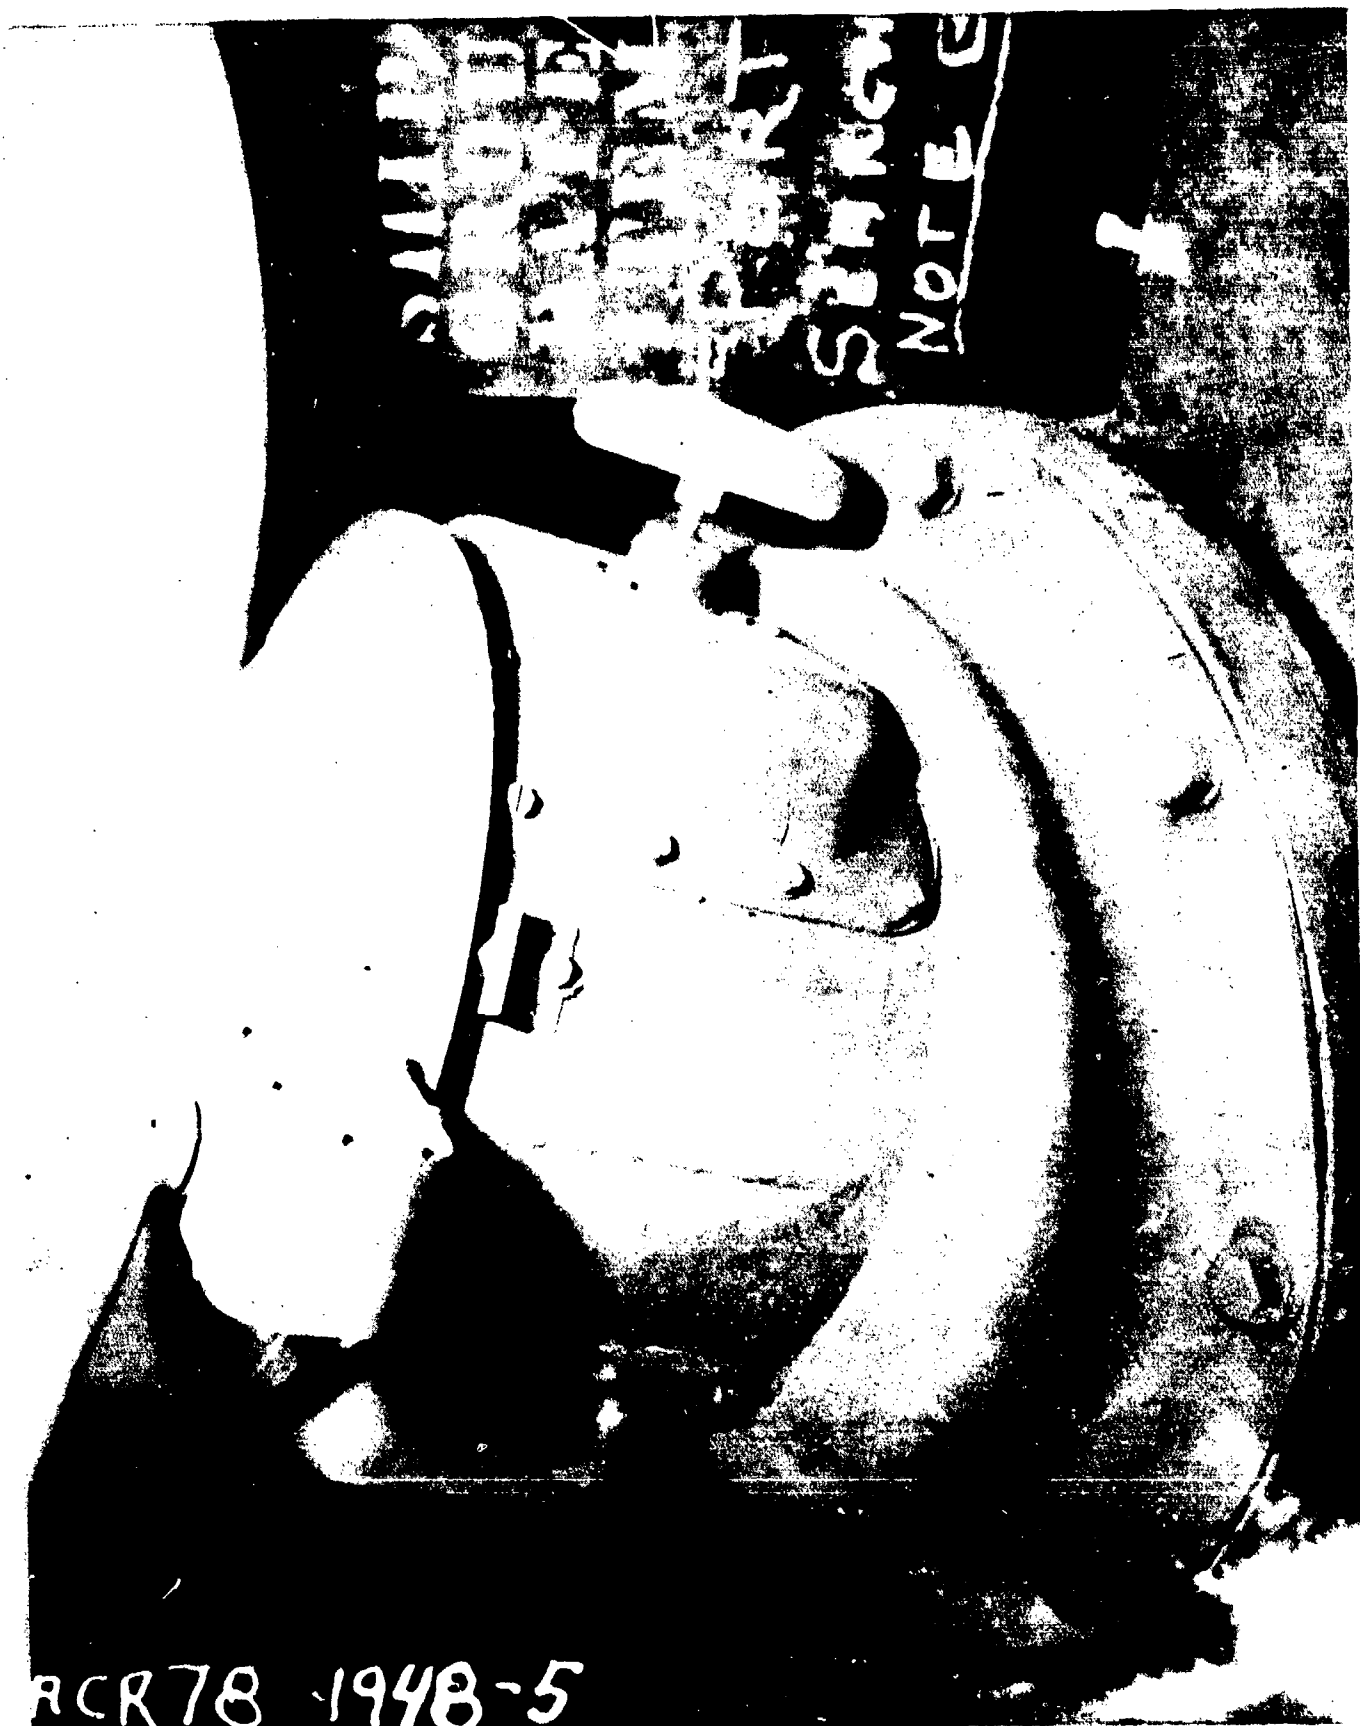
1. The bases were distorted on both 24 inch searchlights. The port searchlight was rendered inoperable.
2. Three gyro repeaters were dislodged from their gimbals rings. However, no material damage resulted to these repeaters and when they were replaced, they were all operable.
3. The port 12 inch signal searchlight was blown over the side.
4. Number 2 fuel oil service pump was rendered inoperable due to a severed cable in its control circuit.
5. The fire alarm circuit for the after cargo hold was rendered inoperable due to a severed cable.
6. The Anemometer cups were carried away by the air blast.
7. Some lamps were broken, mainly on the port side above the main deck.

AA-CR-78-1948-5. Port 24" searchlight, showing the effects of the air blast on its base.

(a) It is recommended that the 24 inch searchlights be redesigned to have resistance to air blast comparable with that of other electrical equipment.
